CONTINUING ELIGIBILITY INSPECTION (CEI) REPORT
FOR FLOOD CONTROL PROJECTS

1. **Project Name:** Wailoa Flood Control Project

2. **Date of Inspection:** November 12, 2002

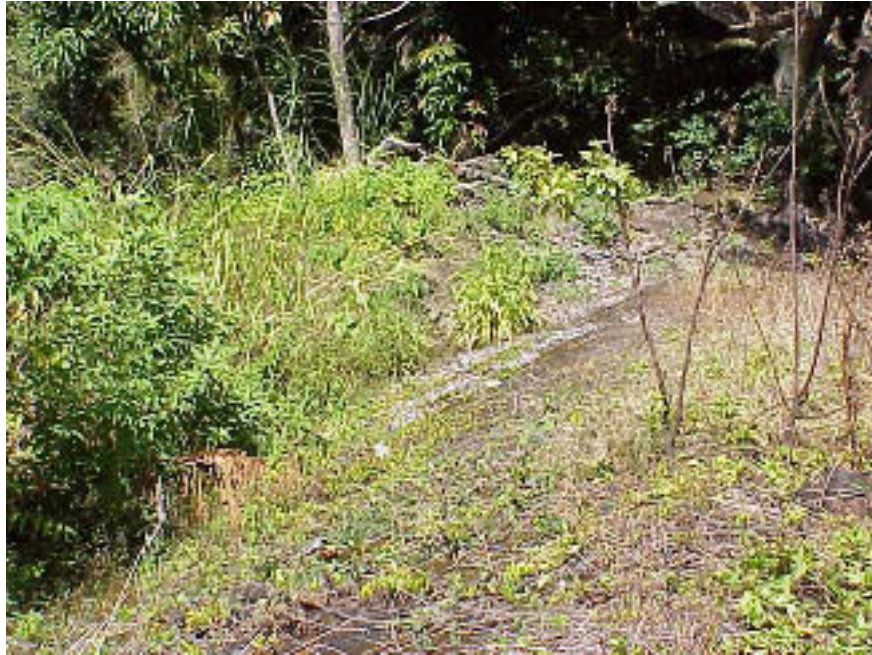
a. Sta. 82+50, Levee # 1, right bank (RB), remove vegetation from CRM sideslope area and channel. (®)

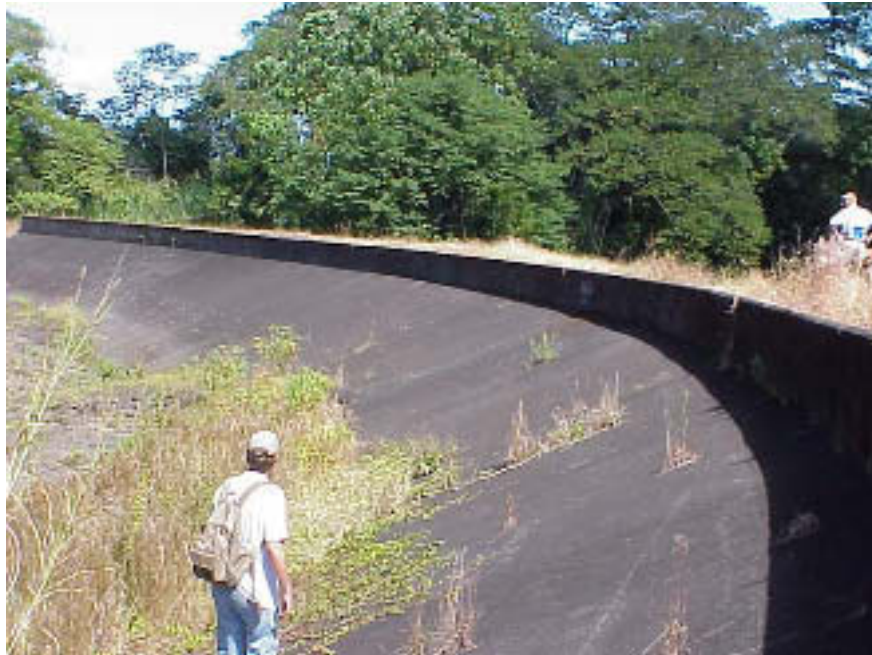
b. Sta. 75+00, Levee #2 (behind UH ballfield), right bank (RB), remove vegetation from sideslope to toe of structure. Continue to monitor cracks on top of channel. (®)

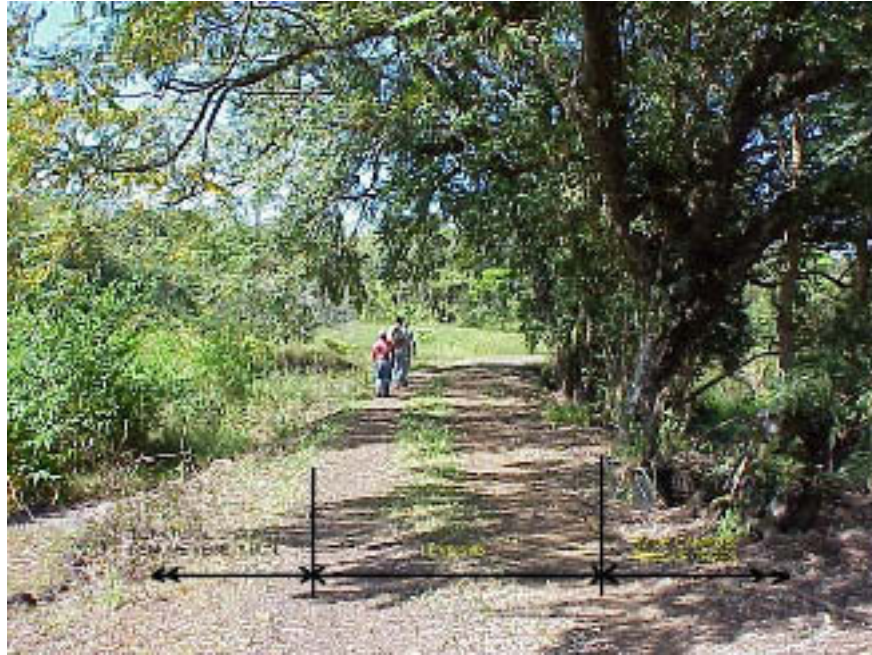
c. Sta. 65+00, RB Levee #3, UH campus must remove vegetation and tree encroachments from levee.

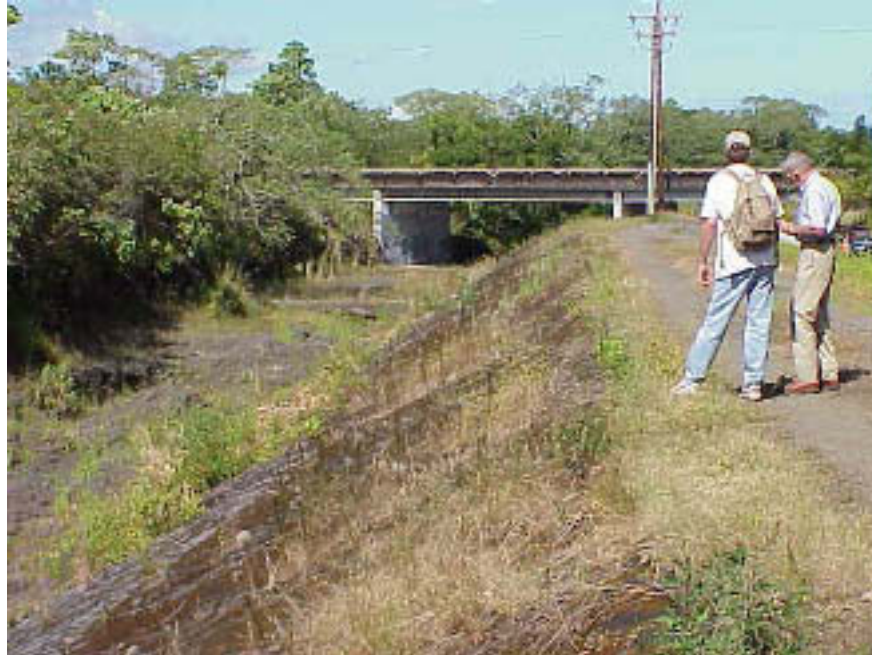
d. Sta. 60+00, RB Levee #3 looking at Lanikaula Bridge, remove vegetation from sideslope and channel.

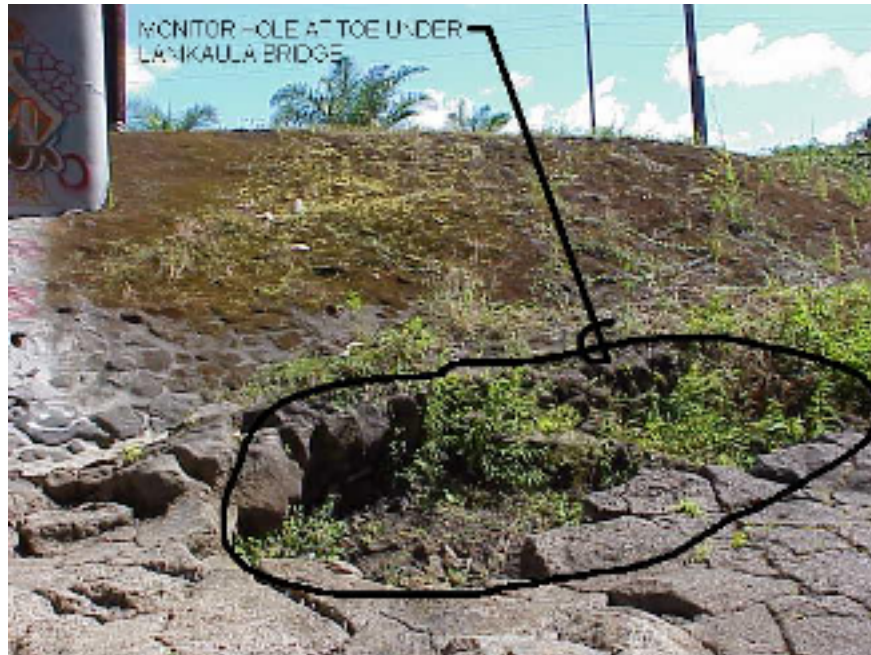
e. Sta. 58+00, RB Levee #3 upstream of Lanikaula Bridge, erosion at toe should be repaired under PL 84-99 construction contract. Refer to (CORPS) plans ring number 30. Monitor the construction of this area.

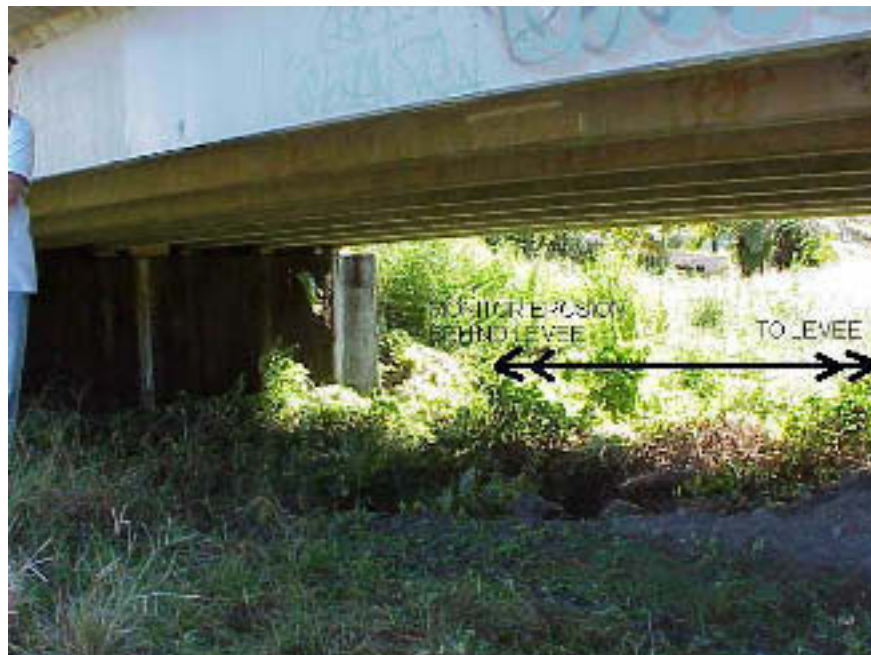
f. Sta. 57+50, RB Levee #3, monitor erosion behind levee underneath Lanikaula Bridge. Should be repaired under (CORPS) plans.

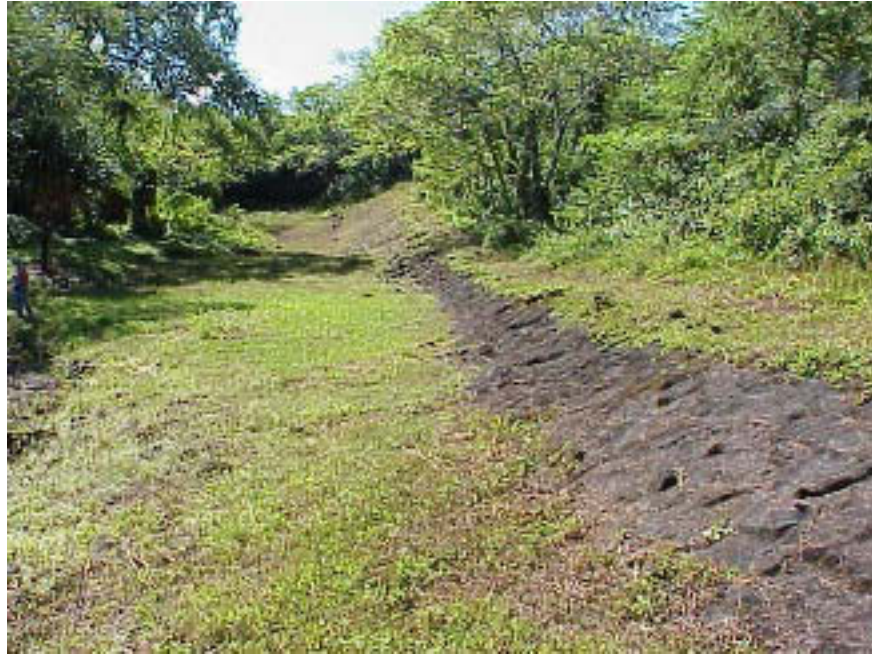
g. Sta. 50+00, LB Levee #4 looking, overview. Continue to control vegetation on levee.

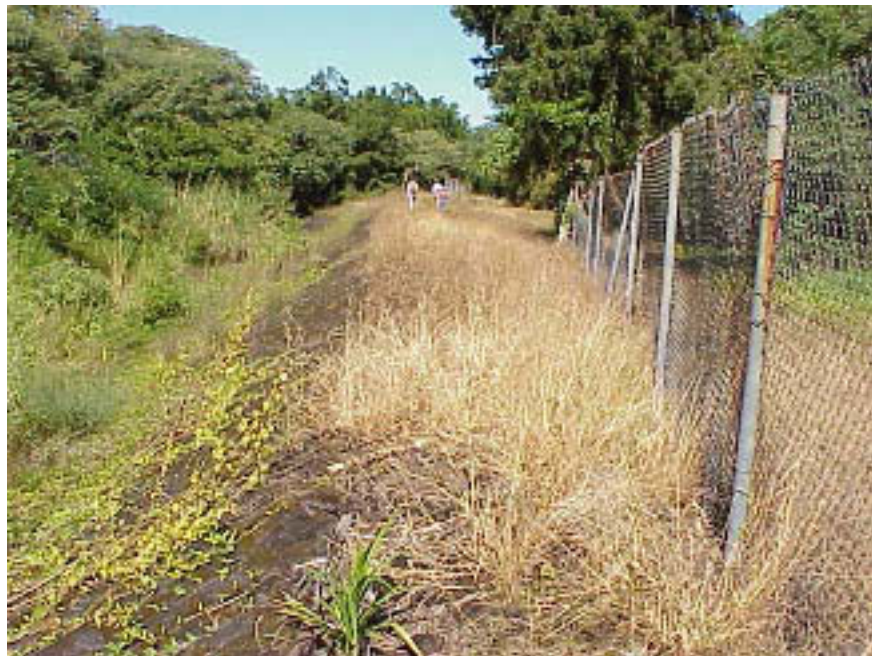
h. Sta. 45+00, RB Levee #5, remove vegetation from sideslope and channel.

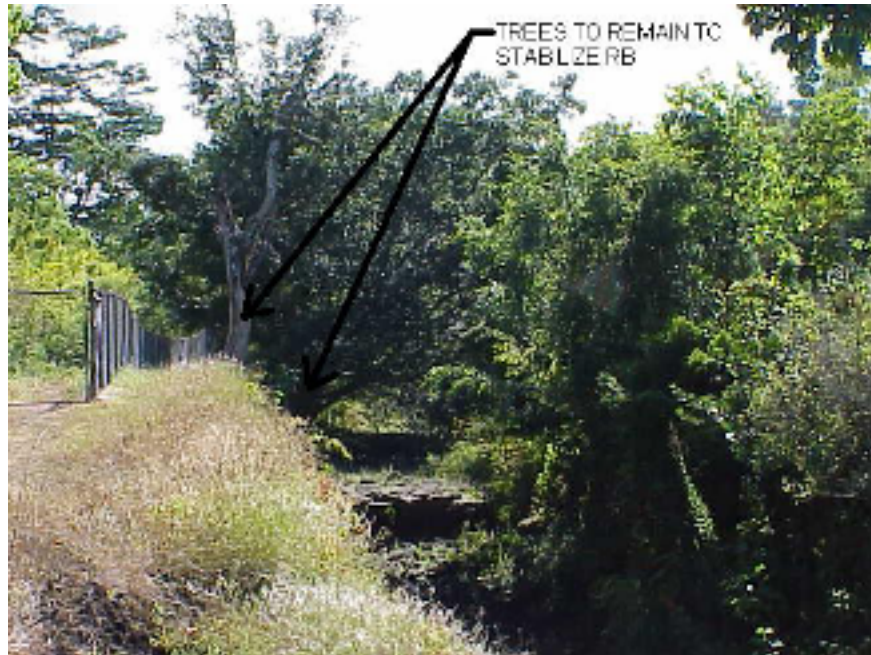
i. Sta. 36+00, RB Levee #6, 2 trees to remain in order to stabilize bank. Cut other grassy vegetation along levee. Trim tree branches and leaves encroaching into channel.

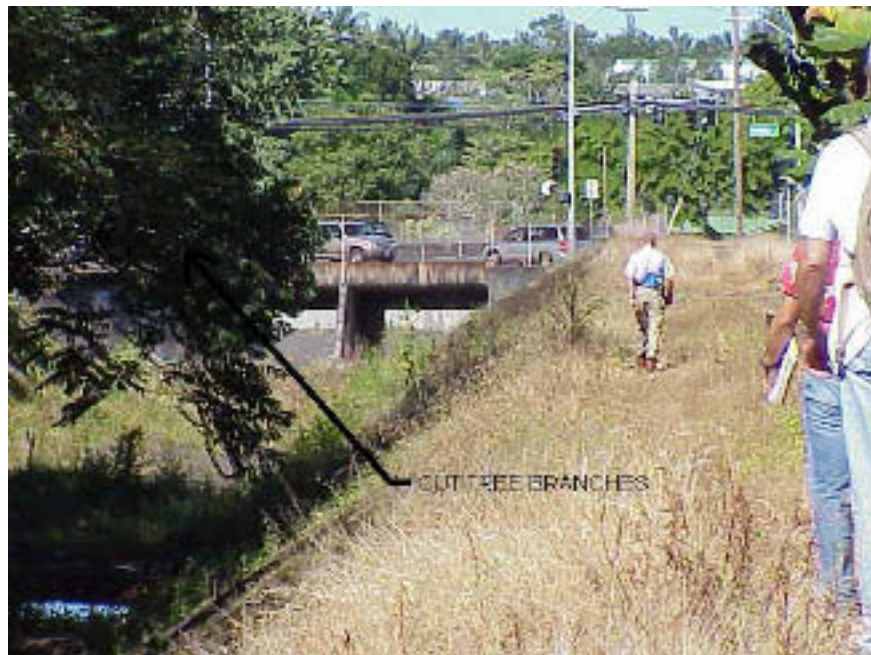
j. Sta. 30+00, RB Levee #6, cut tree branches encroaching into channel.

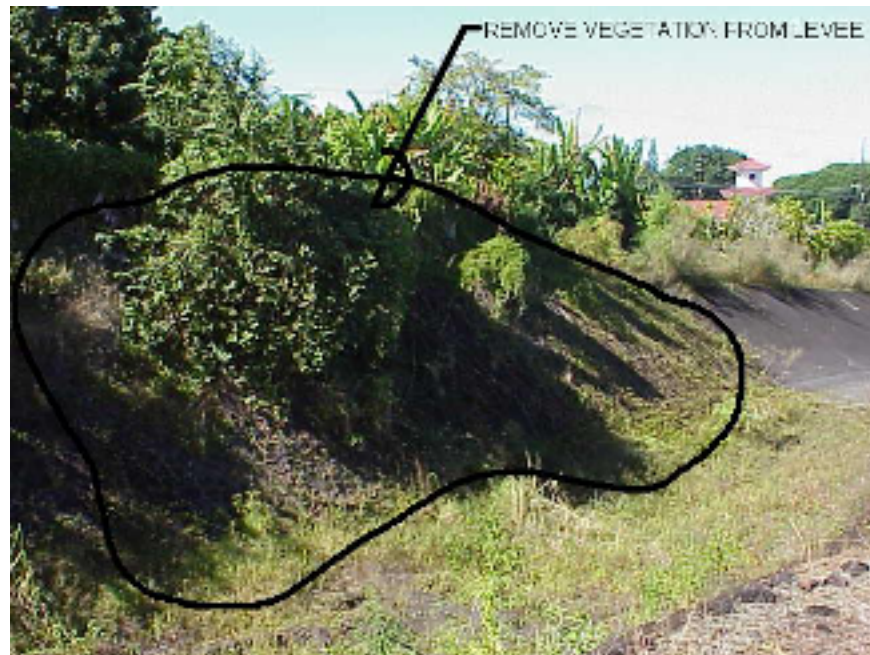
k. Sta. 26+00, left bank (LB) Levee #6A, remove vegetation and tree branches from levee.

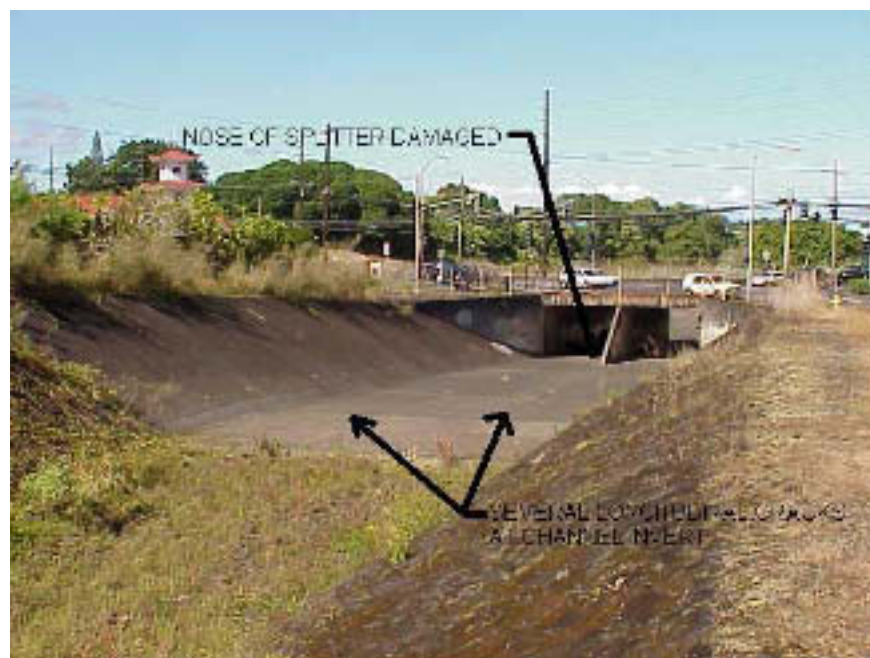
l. Sta. 23+50, channel at Kinoole Bridge, patch several longitudinal cracks at channel invert and monitor damaged splitter nose at bridge.

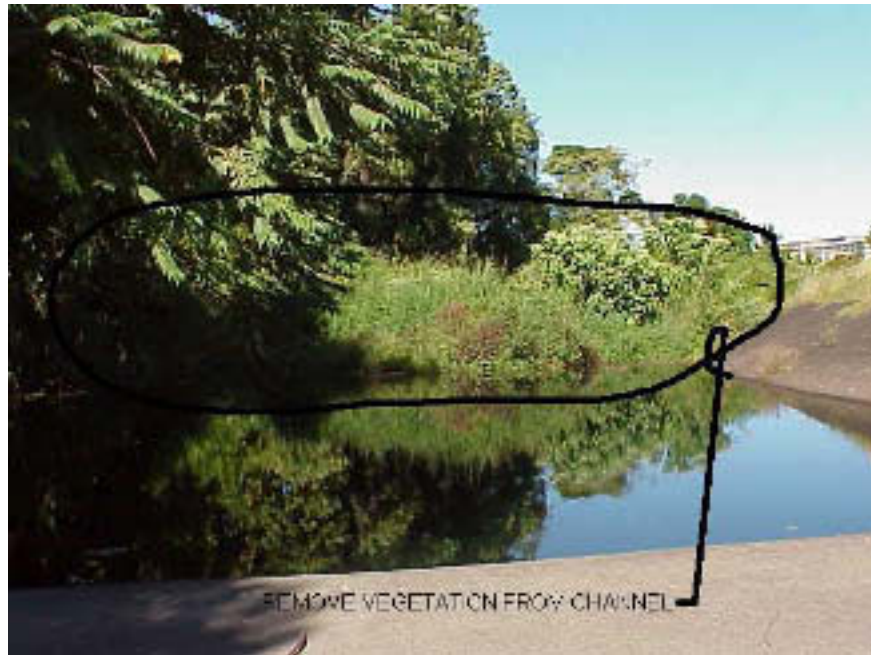
m. Sta. 14+75 to 3+40, channel invert, vegetation debris to be removed under (CORPS) plans ring number 26. Monitor vegetation debris removal.

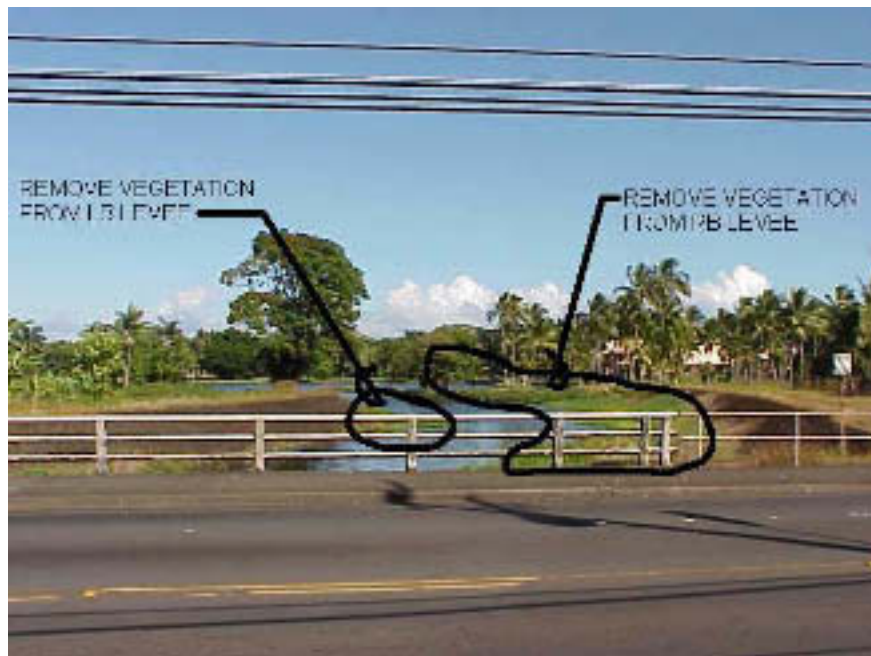
n. Sta. 5+00 to 0+00, RB and LB, remove vegetation from both banks of levee.
